Staff Report and Summary - Conservation Covenant Area Assessment

The Conservation Covenant Area assessment tour was completed this year on September 19 and 29 by RFTA Trails Staff and our third-party consultant, Tom Newland of Newland Project Resources. The tour and corresponding report identify compliance and potential violations as described within the Conservation Restriction Covenant. The nine conservation areas and the locations of activities and potential violations are described based on the Rio Grande Trail mile marker numbering system and the railroad mile post system. The Conservation Restriction Covenant document identifies nine specific classes of potential violations. We found a couple new issues this year and there are still some old violations that need to be resolved, for example the berm and structure on RFTA's ROW along Hooks Spur Rd.

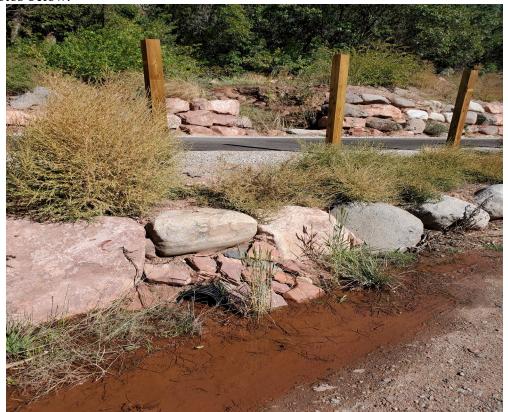
• Category (9) Other at MM 5.5 (MP 365.8) - The Thompson Glen Ditch Company has been on my report previously because of their ditch spoils and also because the ditch has been leaking water for years. This year is no different, I found at several locations with water adjacent to the Rio Grande Trail. See 3 photos below.

Photo – location #1 water from Thompson Glen Ditch seen down along CR 154

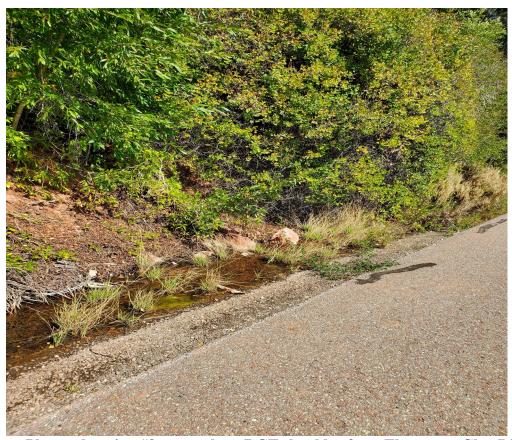
Photo – location #2 water along RGT shoulder from Thompson Glen Ditch

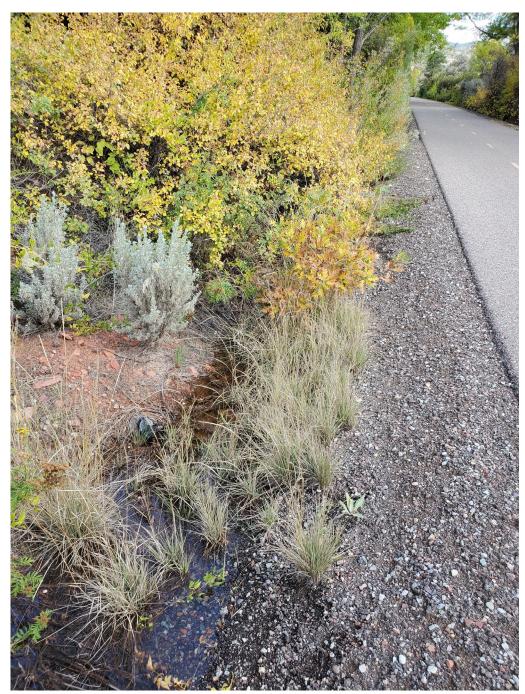
Photo – location #3 ditch water along shoulder of RGT

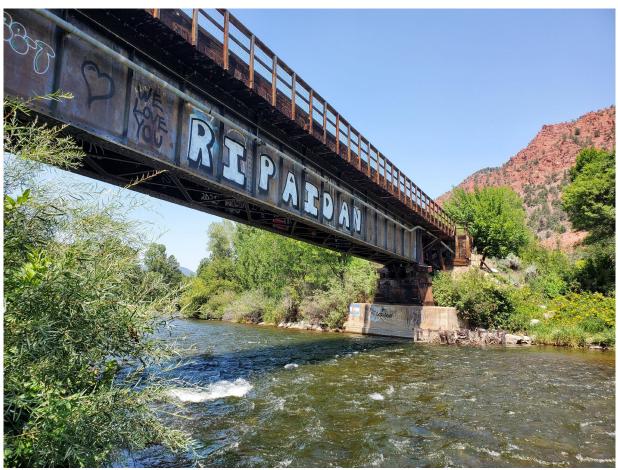
• Category (7) Trash and Category (9) Other at MM 11.5 (MP 371.8) - Ongoing issues with vandalism/graffiti, and trash under the bridge.

Photo of the RF Rail Bridge and an example of the graffiti.

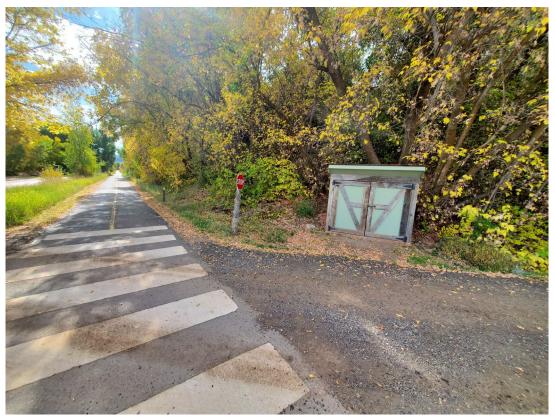
• Category (1) Construction of Buildings and/or Other Structures at MM 18.9 (MP 379.15) - The trash house on RFTA ROW has not been moved off the corridor. See photo below.

Photo - Trash House on RFTA ROW

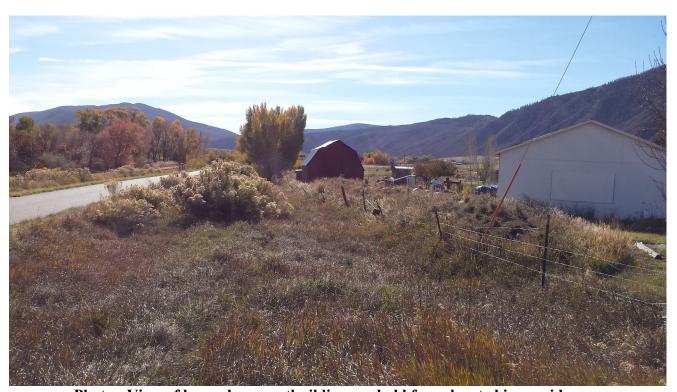
Category (1) Construction of Buildings and/or Other Structures at MM 19.63 (MP 379.9) - Barn, berm, fence, and outbuilding on RFTA Property. Staff has been coordinating with the Property owner and working towards a resolution. Staff has engaged a local Contractor to move the berm and barn off RFTA Property. Please refer to photo below and the following text is drawn verbatim from the 2010 report:

"The fence, berm, irrigation system and out building noted in area 6 involve a landowner who has been approached regarding these corridor incursions in prior years and provided RFTA with a letter stating their willingness to remove the berm and fence, but who so far has taken no action to rectify the situation. Staff recommendation is that the berm, fence and barn be removed or relocated back onto the adjacent landowner's property for the following reasons: first, the structures restrict the access of the public to public lands; second, the structures are inconsistent or are maintained in a fashion that is inconsistent with the general character of a rural environment embodying significant conservation values; and third, the structures present a negative impact on the use of this public property by wildlife."

Photo - View of berm, barn, outbuilding, and old fence located in corridor

Staff recommendation remains unchanged for the 2023 report.

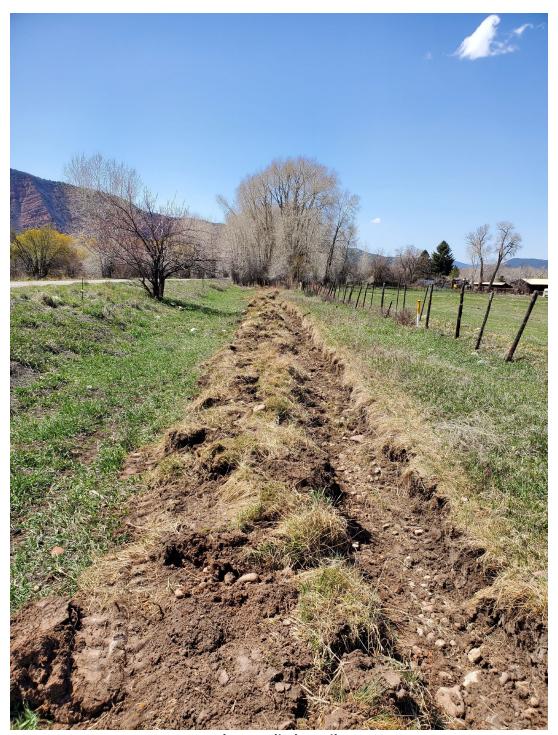
• Category (9) Other at MM 20.8 to 21.46 (MP 381.08 to 381.75 – A ditch company cleaned their ditch this spring and left their spoils all over RFTA ROW. No attempt was made to reseed or restore the property to as good or better condition. See photos below.

Photo – ditch spoils

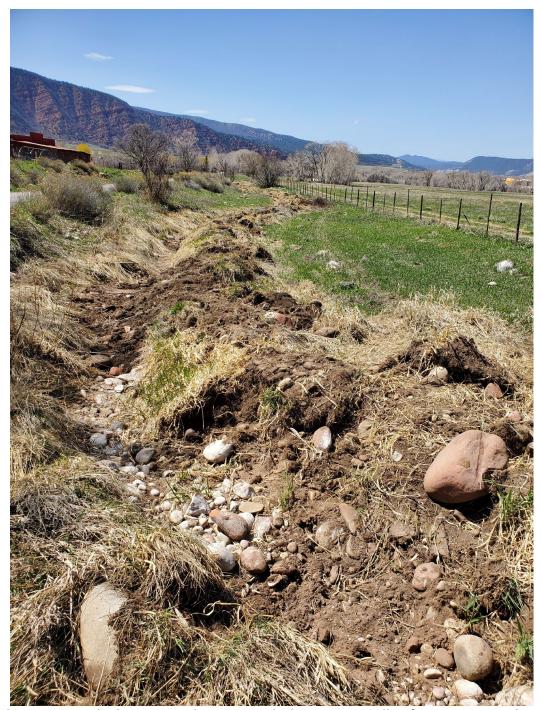
Photo – same ditch company leaving spoils, but just up-valley from previous photo

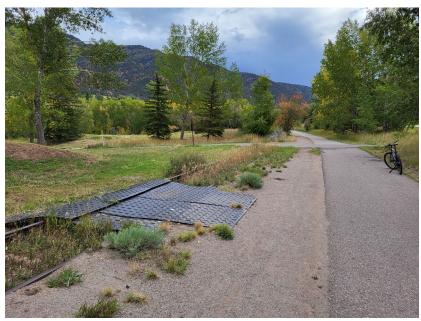
• Category (9) Other at MM 24.52 (MP 384.8) - The Roaring Fork Club continues to use RFTA ROW for their golf course operations, without coordination or permission. See photo below of a new rail crossing.

Photo – new rail crossing

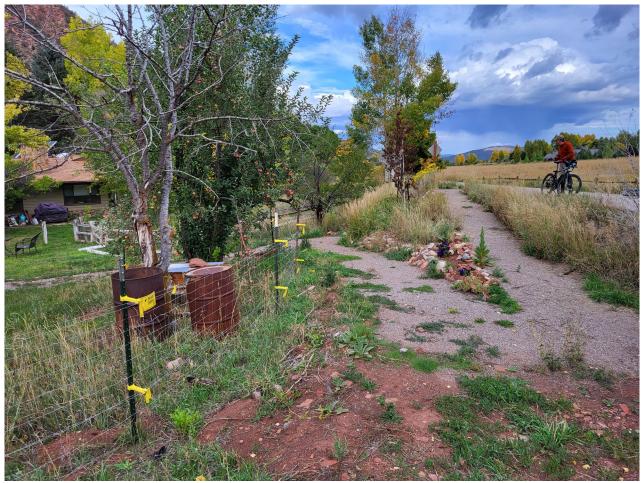
- Category (6) Paving and Road and Trail Construction at MM 25 25.15 (MP 385.25 to 385.4) A neighbor constructed a private connection to the RGT in 2021 with no signs of removing. This is not the only house in this neighborhood to create a soft surface trail (and other improvements) from their backyard up to the RGT, however this particular one is the most intensive/offensive. Do we need to ask the entire neighborhood to remove individual trails (and other improvements) and consolidate into 1 access? See photos below.
- Category (2) Fences multiple neighbors also have fences encroaching

Photo – private trail connection and other improvements

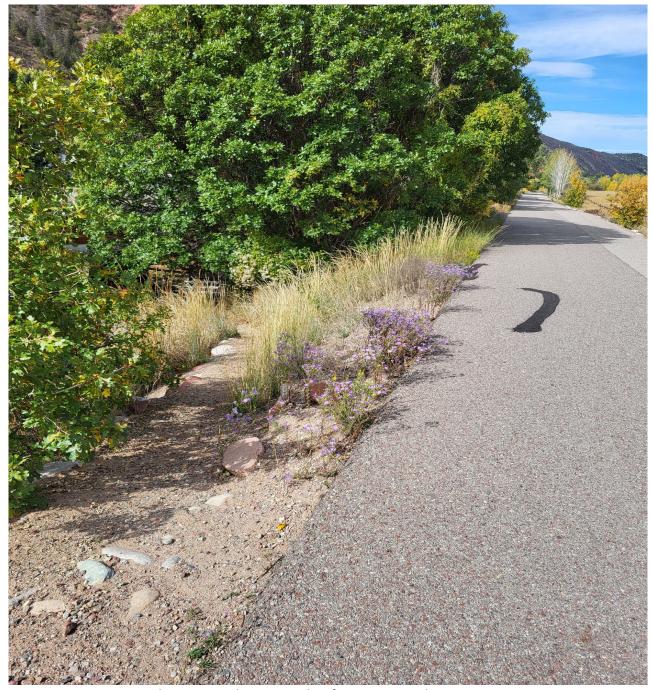
Photo – another example of a private trail connection

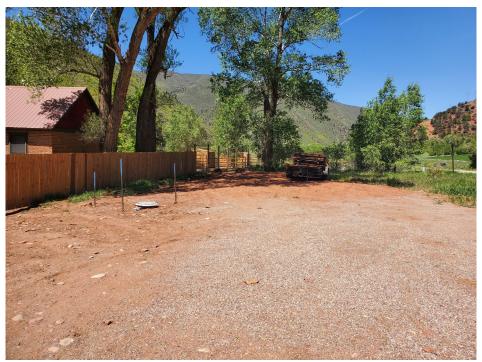
• 1) Construction of Buildings and/or Other Structures at MM 27.15 (MP 387.5) – Early this summer, a contractor "accidentally" installed a septic system (or cistern) on RFTA ROW. Because they did not get permission, RFTA notified them to remove any and all improvements and return the property in as good or better condition. They have since removed the encroachments and seeded the property. See photos below.

Photo – septic/cistern in June 2022

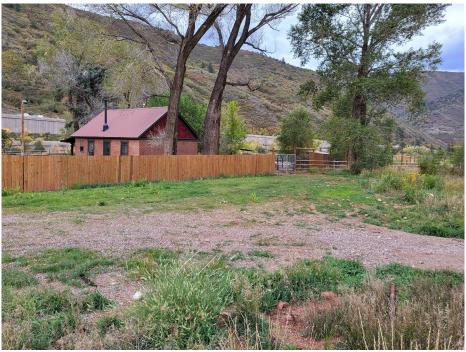
Photo – site "restored" in September 2022
